## INDIANA DEPARTMENT OF ENVIRONMENTAL MANAGEMENT

Re: **Inspection Summary/Violation Letter**  
Yard 520 Landfill  
Permit # 64-04/64-07  
Town of Pines, Porter County

# AGRICULTURAL AND SOLID WASTE COMPLIANCE

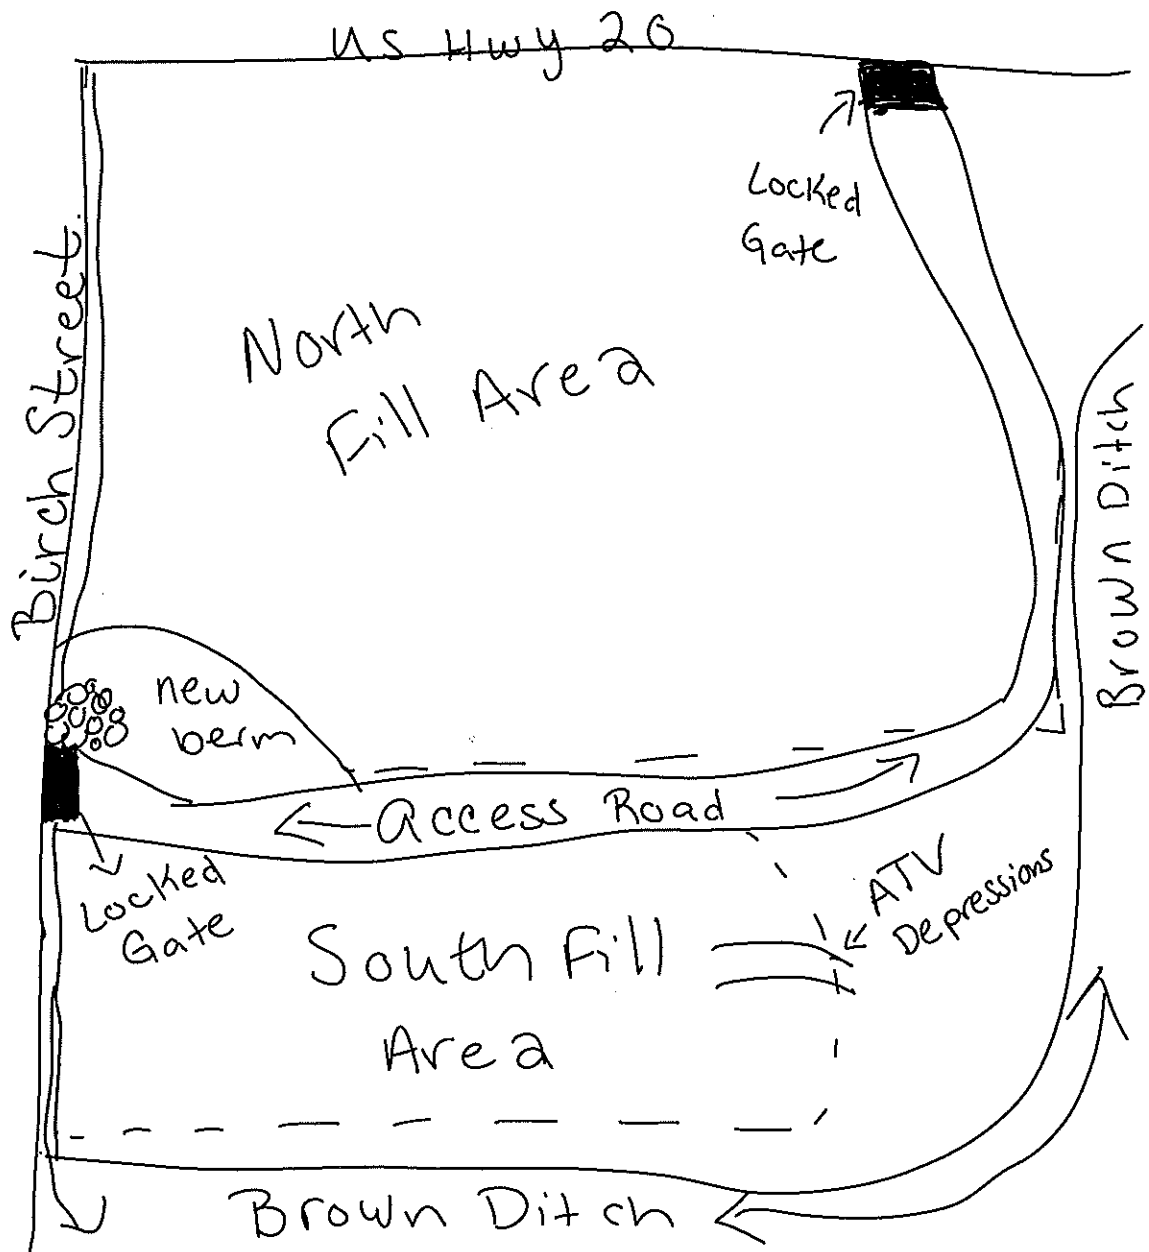
The seepage outbreak area on the West slope of the North fill was completely re-graded and the slope was re-contoured. The area was packed with clay and seeded. Per the completion repair report 730 cubic yards of clayey soil has been placed in this area. There is currently a mesh blanket over the seeded area as the vegetation has not completely sprouted yet. The storm water ditch line that runs parallel to Birch Street was also cleaned out and a new drainage tile was inserted to aid in moving storm water away from the landfill. This area looked to be in compliance and no leachate/ seepage was observed while on site today however in the last 48 hours the weather has been dry and warm.

The West slope of the North fill showing the areas that have been re-contoured and capped with clay. Vegetation is starting to sprout up here.
